Response to 83 Illinois Administrative Code
411 – 2002 Annual Report
May 29, 2003

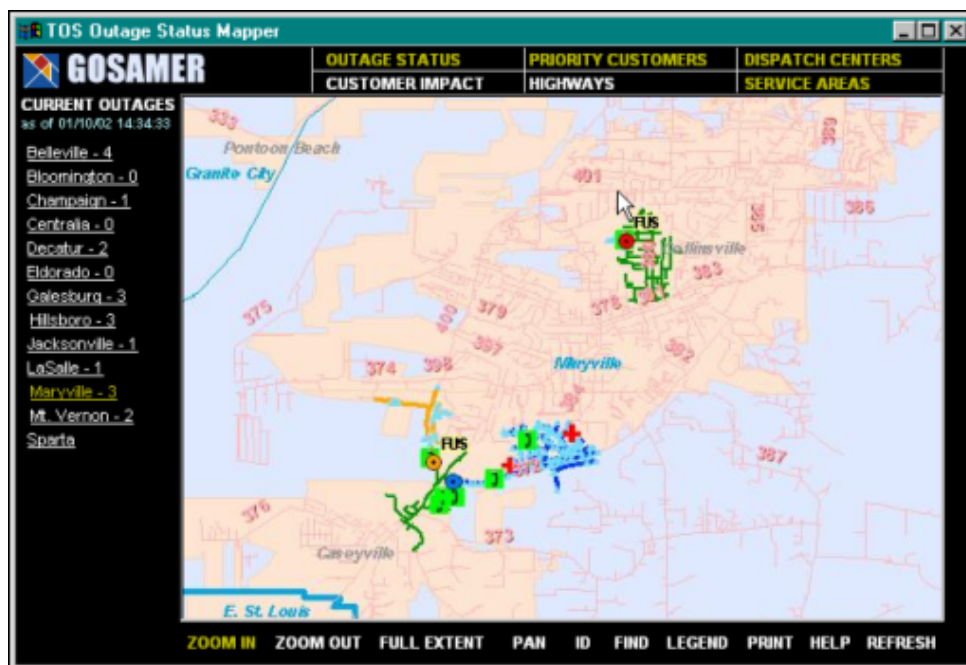
Figure 16 TOS Visual Basic View

- In 2003, a Visual Basic tool was installed on the front end of TOS. This view allows dispatchers to study a graphic representation of affected devices during an outage. The dispatcher can use this information to make a more informed decision regarding proximity of available resources to the outage location. The user can zoom in or zoom out on an area to aid in the decision process. Figure 16 shows this real-time visualization of TOS.

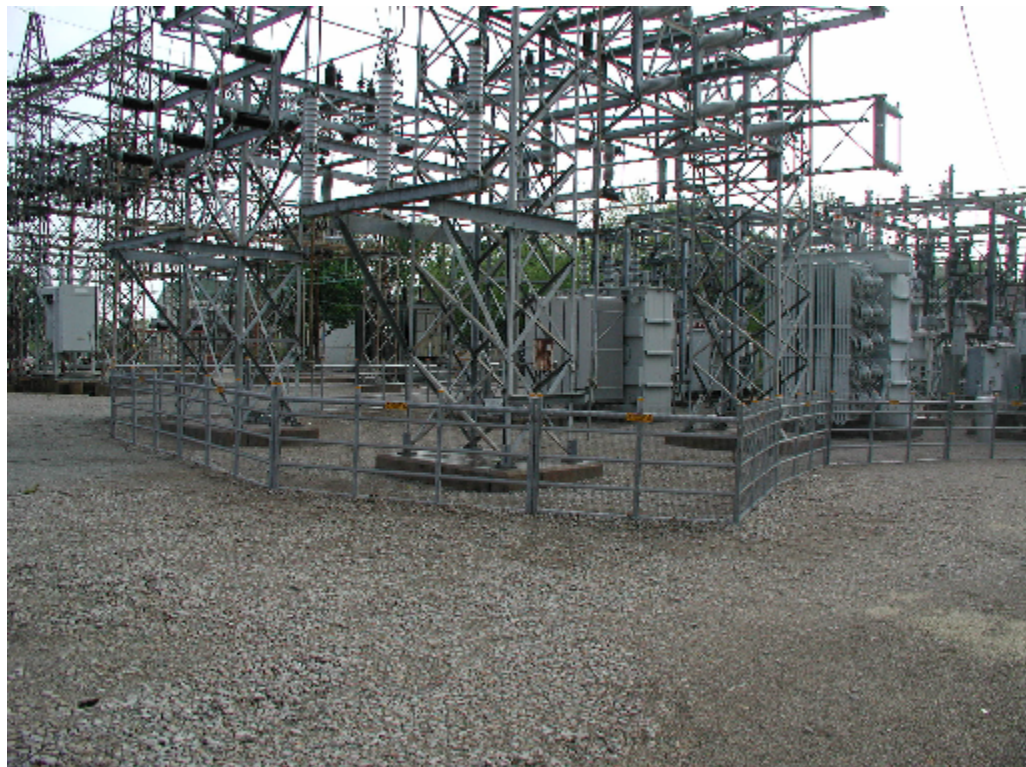
Figure 17 Electronic Fence Inside Substation Fence

In addition to traditional animal protection at substations, Illinois Power installed an electronic fence inside the outer fence at a substation in 2002. This low-voltage fence presented in Figure 17 is designed to prevent intrusion from the ground level up. This application will be monitored and evaluated for further use.
